Group 3: Michal Bartusiewicz, Steve Cullen, Dong-Hyun Chung, Kate Horlocker, Na Ning, and Bin Tong

The Leaning Tower of Pisa – Task 1

I. Introduction to the Leaning Tower of Pisa

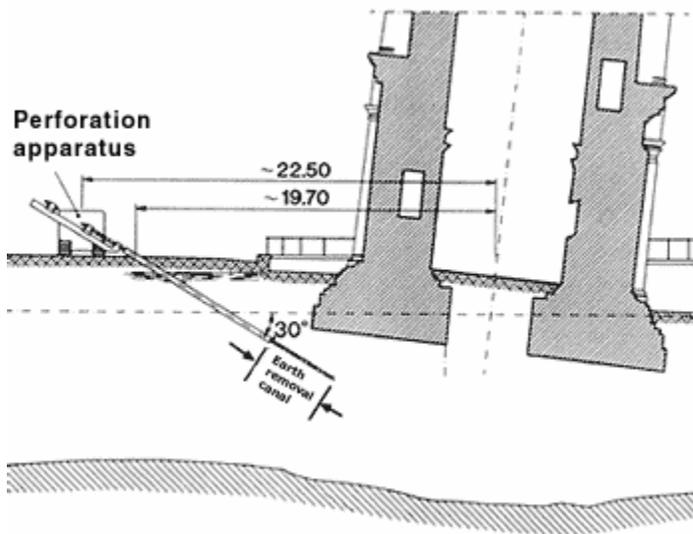
http://torre.duomo.pisa.it/towersposters/english_version/10/perforazioni.gif

- 2. Its goal was to excavate the earth from beneath the Tower's foundation on its northern side so that the Tower would tilt back toward the perpendicular.
